dsPIC33CK256MP508 Family Silicon Errata and Data Sheet Clarification

The dsPIC33CK256MP508 family devices that you have received conform functionally to the current Device Data Sheet (DS70005349K), except for the anomalies described in this document.

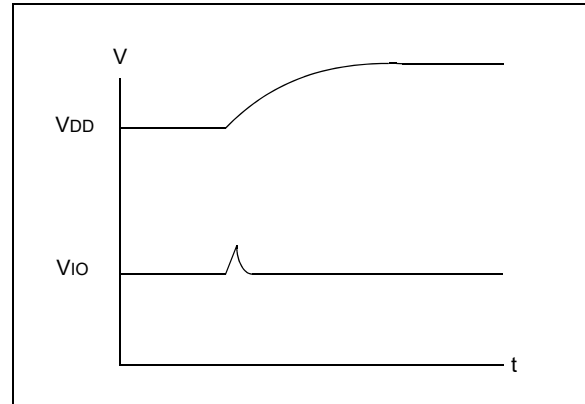
FIGURE 1-1: I/O RAMP

During a fast device power-up when the V_{DD} ramp is less than 4 mS, the I/O pins may drive up to 100 μ A current for a duration of up to 10 μ S (Figure 1-1).

Example applications affected may include complementary power switches, where a transient current shoot-through might occur. High-voltage applications with complementary switches should power the high-voltage 200 μ Sec later than powering the dsPIC[®] device to avoid the current shoot-through. This behavior is specific to each device and not affected by aging.

1. Slow down the V_{DD} ramp time (greater than 4 mS for V_{DD} to ramp 0V to 3.3V).
2. Ensure the circuitry that is connected to the pins can endure this pulse.
