## LTC2872

## Half-Duplex Control Issue

Reported: July 2012 Resolved: March 2013

## Update: This LTC2872 issue was corrected beginning with product date code 1339.

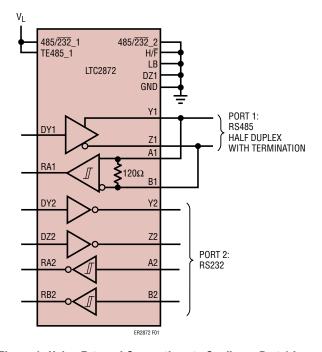
Figure 1. Using External Connections to Configure Port 1 in RS485 Mode, Half Duplex, While Port 2 is in RS232 Mode

This issue only surfaces when one port is configured in RS232 mode and the other port is configured in RS485 mode, half duplex. The devices can be wired in half duplex mode externally if this configuration is required, as shown in Figure 1. In this case, if the internal termination is required for the RS485 lines, set TE485 high and DZ low on the port that is configured for RS485. Setting DZ low disables the  $120\Omega$  driver termination resistor between Y and Z, so that it is not in parallel with the  $120\Omega$  receiver termination resistor between A and B.
